**Flood Control Project Maintenance
Levee Inspections**
LMA District Cover Sheet
Spring 2019 Levee Inspection Results

Yolo County Department of Natural Resources

Spring 2019 Levee Inspection Results

Waterway			Bank	Unit Miles
Unit No. 01 Right Bank Cache Creek			Right	0.59
	Spring (March - May)	Summer (June - August)	(September - November) Fall	Winter (December - February)
Unit Maintenance Rating (Fall Only)				
Date of Inspection	3/29/2019 - 3/29/2019			
DWR Inspector	Zach Jojola			
Accompanied By	Casey Leibler Yolo County Department of Natural Resources			
	Thomas Engler MBK

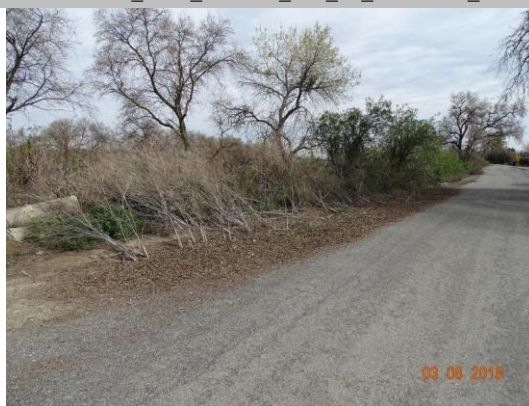
Photo 1 of 2 : SP_2019_NA0021_351_23_20190304_00016.jpg

LM Start	0.03	Rating **	U	Issue No.	23
LM End	0.07	Issue Type +	Ma	Location *	WS
Category	Earthen Levee			GPS Latitude/Longitude	
				Start	End
Item	Vegetation			38.720892 °	38.721020 °
				-121.810421 °	-121.809792 °
DWR ID	DWR_NA0021_01_s_2017_23				
Comment Code					
V2 : Remove the wild growth other than native grasses from the levee slopes.					
Inspector Comment					
There is thick vegetation on waterside slope blocking visibility.

Wild vegetation on the waterside levee slope, Spring 2018.

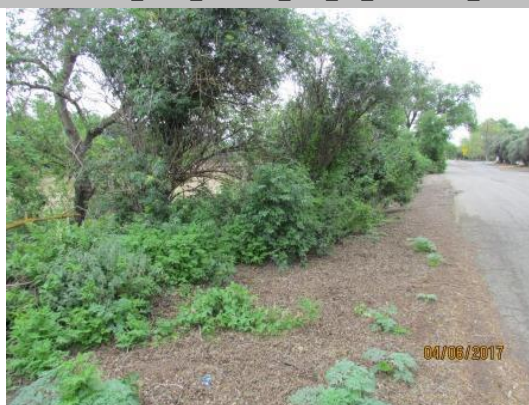
Photo 2 of 2 : SP_2019_NA0021_351_23_20190304_00017.jpg

Wild vegetation on waterside levee slope, Spring 2017.

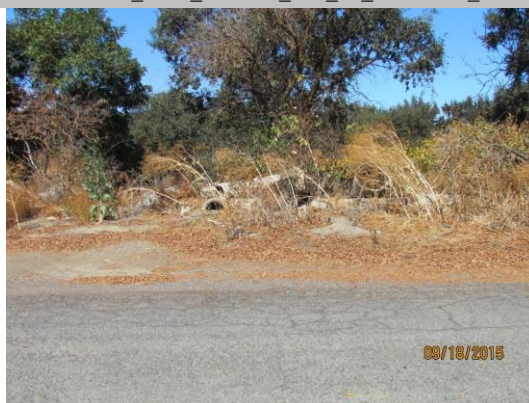
Photo 1 of 1 : SP_2019_NA0021_351_15_20190304_00007.jpg

LM Start	0.03	Rating **	M	Issue No.	15
LM End	0.03	Issue Type +	Ma	Location *	WS
Category	Earthen Levee			GPS Latitude/Longitude	
				Start	End
Item	Encroachments			38.720895 °	38.720895 °
				-121.810408 °	-121.810408 °
DWR ID	DWR_NA0021_01_f_2015_15				
Comment Code					
DE : Debris					
Inspector Comment					
Concrete pipes are located on the waterside slope.

View of the debris on the waterward side of the levee. Fall 2015.

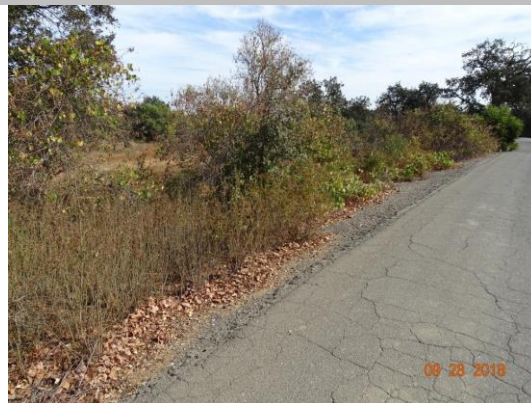
Photo 1 of 1 : SP_2019_NA0021_351_6_20190304_00002.jpg

LM Start	0.09	Rating **	U	Issue No.	6
LM End	0.13	Issue Type +	Ma	Location *	WS
Category	Earthen Levee			GPS Latitude/Longitude	
				Start	End
Item	Vegetation			38.721086 °	38.721222 °
				-121.809451 °	-121.808650 °
DWR ID	DWR_NA0021_01_f_2018_6				
Comment Code					
V2 : Remove the wild growth other than native grasses from the levee slopes.					
Inspector Comment

View of the vegetation on the waterside slope. Fall 2018.

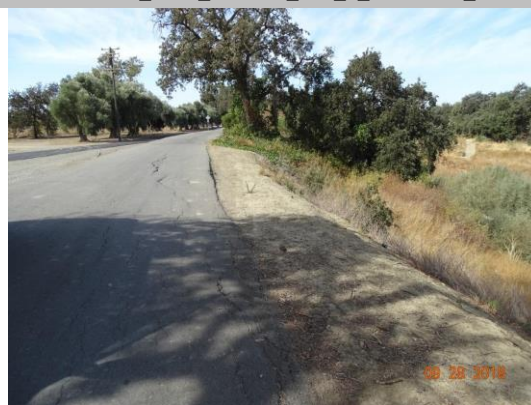
Photo 1 of 1 : SP_2019_NA0021_351_9_20190304_00006.jpg

LM Start	0.14	Rating **	A/W	Issue No.	9
LM End	0.14	Issue Type +	Ob	Location *	CR
Category	Earthen Levee			GPS Latitude/Longitude	
				Start	End
Item	Cracking			38.721260 °	38.721260 °
				-121.808496 °	-121.808496 °
DWR ID	DWR_NA0021_01_f_2018_9				
Comment Code					
CR1 : Monitor and have inspected by geotechnical engineer.					
Inspector Comment					
There is longitudinal cracking on the crown and waterside slope. There is potential for sloughing within the crown. Recommend monitoring.

View of the longitudinal cracking on the crown and waterside slope. Fall 2018.

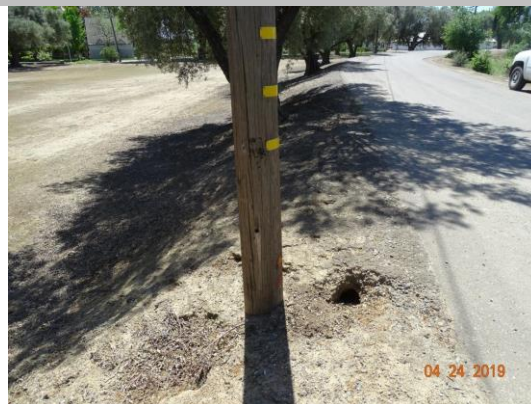
Photo 1 of 3 : SP_2019_NA0021_351_16_20190424_00021.jpg

LM Start	0.19	Rating **	U	Issue No.	16
LM End	0.19	Issue Type +	Ma	Location *	LS
Category	Earthen Levee			GPS Latitude/Longitude	
				Start	End
Item	Animal Control			38.721536 °	38.721536 °
				-121.807711 °	-121.807711 °
DWR ID	DWR_NA0021_01_s_2015_16				
Comment Code					
A3 : No rodents visible, but rodent burrows visible; need to backfill and compact or grout burrows.					
Inspector Comment

View of rodent hole on the landside slope next to power pole. Spring 2019.

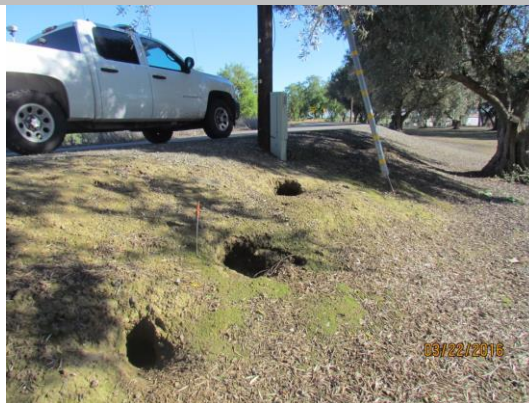
Photo 2 of 3 : SP_2019_NA0021_351_16_20190304_00010.jpg

LM Start	0.19	Rating **	U	Issue No.	16 (cont)	
LM End	0.19	Issue Type +	Ma	Location *	LS	
Category	Earthen Levee			GPS Latitude/Longitude		
				Start		End
Item	Animal Control			38.721536 °		38.721536 °
				-121.807711 °		-121.807711 °
DWR ID	DWR_NA0021_01_s_2015_16					
Comment Code						
A3 : No rodents visible, but rodent burrows visible; need to backfill and compact or grout burrows.						
Inspector Comment

View of the rodent holes on the landward side of the levee looking downstream. Spring 2016.

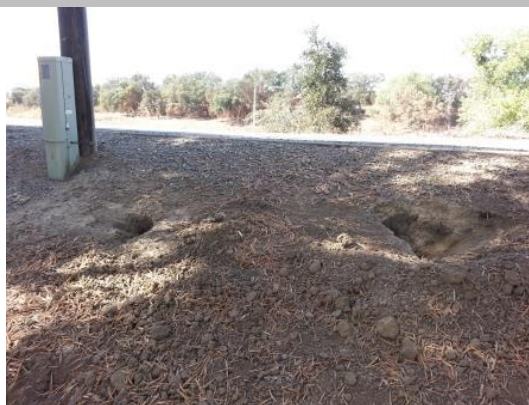
Photo 3 of 3 : SP_2019_NA0021_351_16_20190304_00008.jpg

View of rodent holes on landside slope. Fall 2016.

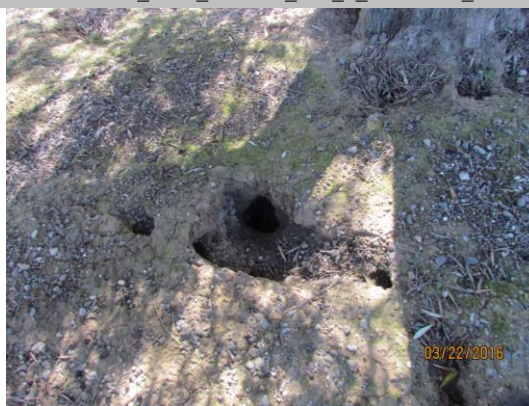
Photo 2 of 2 : SP_2019_NA0021_351_7_20190304_00004.jpg

LM Start	0.20	Rating **	M	Issue No.	7 (cont)	
LM End	0.20	Issue Type +	Ma	Location *	LS	
Category	Earthen Levee			GPS Latitude/Longitude		
				Start		End
Item	Animal Control			38.721683 °		38.721683 °
				-121.807532 °		-121.807532 °
DWR ID	DWR_NA0021_01_s_2016_7					
Comment Code						
A3 : No rodents visible, but rodent burrows visible; need to backfill and compact or grout burrows.						
Inspector Comment

Animal hole is close to the shoulder of the levee. Spring 2016.

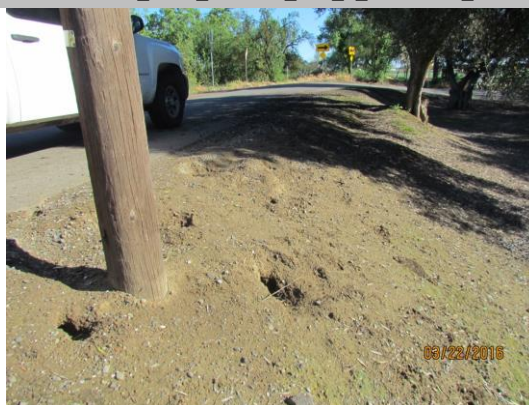
Photo 1 of 1 : SP_2019_NA0021_351_8_20190304_00005.jpg

LM Start	0.22	Rating **	M	Issue No.	8
LM End	0.22	Issue Type +	Ma	Location *	LS
Category	Earthen Levee			GPS Latitude/Longitude	
				Start	End
Item	Animal Control			38.721876 °	38.721876 °
				-121.807393 °	-121.807393 °
DWR ID	DWR_NA0021_01_s_2016_8				
Comment Code					
A3 : No rodents visible, but rodent burrows visible; need to backfill and compact or grout burrows.					
Inspector Comment

View of the rodent holes on the landward side of the levee looking downstream. Spring 2016.

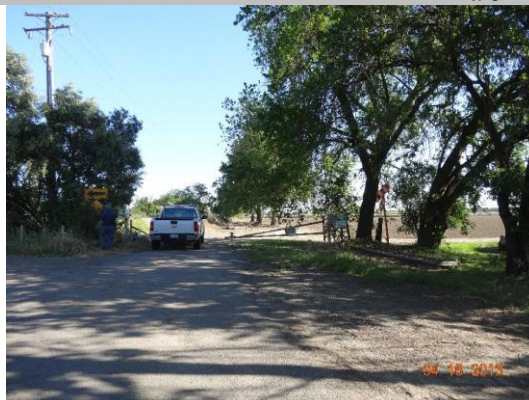
Photo 1 of 3 : UCIP_SP_2019_39855_69553.jpg

Comment Code					
Inspector Comment					
FS_ID:39855 DS_ID:19554 EP_NO: 6790 Repair Type: Non-Urgent Crossing Status: Indicator Found UCIP Comments: Need to contact owner to determine if crossing is still active and to determine last inspection date. Will need copy of letter showing crossings passed inspection. FIELD_STRUCT_DESC: 6-inch steel natural gas pipeline through the levee, 4 feet below the crown. Pipe extends from borrow area and under the channel. Bleeder valve on the waterside (WS) bank. Service vault located on the landside (LS) next to access gate. Paved access ramp on the LS slope. (Plans to lower a 6-inch high-pressure gas main crossing Cache Creek authorized under Permit No. 6790, 1969 - Pacific Gas and Electric Company [PG&E]). [Additional Reference(s): DWR Levee Log, 2004]. FS Date: 4/16/2013

View of landward side near access gate. Gas line marker located on between trees. Line runs parallel to access roadway and through levee.

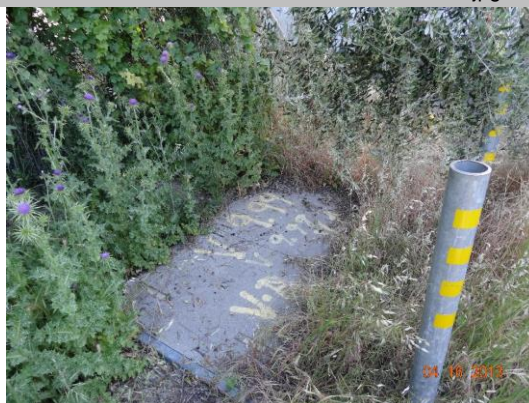
Photo 2 of 3 : UCIP_SP_2019_39855_69554.jpg

Service vault located on landward toe near gate access gate.

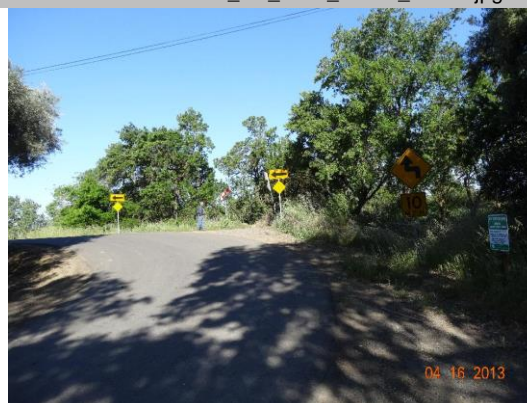
Photo 3 of 3 : UCIP_SP_2019_39855_69555.jpg

Comment Code						
Inspector Comment						
FS_ID:39855						
DS_ID:19554						
EP_NO: 6790						
Repair Type: Non-Urgent						
Crossing Status: Indicator Found						
UCIP Comments: Need to contact owner to determine if crossing is still active and to determine last inspection date. Will need copy of letter showing crossings passed inspection.						
FIELD_STRUCT_DESC: 6-inch steel natural gas pipeline through the levee, 4 feet below the crown. Pipe extends from borrow area and under the channel. Bleeder valve on the waterside (WS) bank. Service vault located on the landside (LS) next to access gate. Paved access ramp on the LS slope. (Plans to lower a 6-inch high-pressure gas main crossing Cache Creek authorized under Permit No. 6790, 1969 - Pacific Gas and Electric Company [PG&E]). [Additional Reference(s): DWR Levee Log, 2004].						
FS Date: 4/16/2013

View of gas line marker located on levee crown.

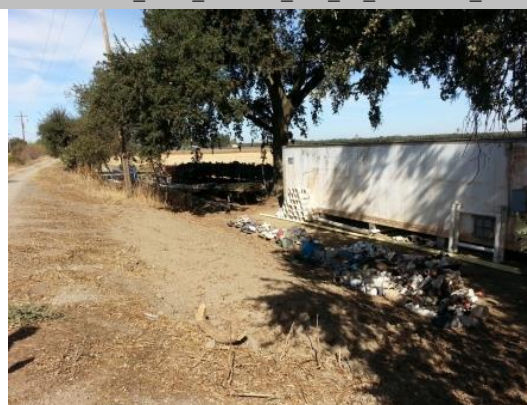
Photo 1 of 2 : SP_2019_NA0021_351_18_20190304_00011.jpg

LM Start	0.27	Rating **	M	Issue No.	18
LM End	0.27	Issue Type +	En	Location *	LS
Category	Earthen Levee			GPS Latitude/Longitude	
				Start	End
Item	Encroachments			38.722615 °	38.722615 °
				-121.806952 °	-121.806952 °
DWR ID	DWR_NA0021_01_s_2015_18				
Comment Code					
EQ : Equipment					
Inspector Comment

Photo of equipment near LS toe of the levee. Fall inspection 10/07/2016.

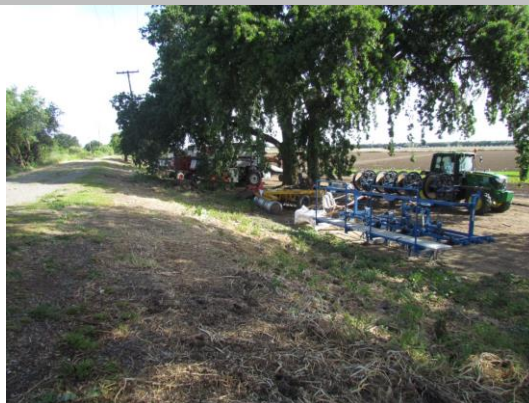
Photo 2 of 2 : SP_2019_NA0021_351_18_20190304_00012.jpg

LM Start	0.27	Rating **	M	Issue No.	18 (cont)	
LM End	0.27	Issue Type +	En	Location *	LS	
Category	Earthen Levee			GPS Latitude/Longitude		
				Start		End
Item	Encroachments			38.722615 °	38.722615 °	
				-121.806952 °	-121.806952 °	
DWR ID	DWR_NA0021_01_s_2015_18					
Comment Code						
EQ : Equipment						
Inspector Comment

View of equipment on the landward side of the levee looking downstream. Spring 2015.

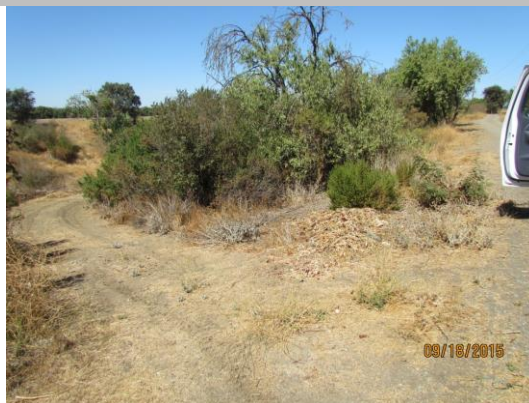
Photo 1 of 3 : SP_2019_NA0021_351_22_20190304_00013.jpg

LM Start	0.27	Rating **	M	Issue No.	22
LM End	0.27	Issue Type +	En	Location *	WS
Category	Earthen Levee			GPS Latitude/Longitude	
				Start	End
Item	Encroachments			38.722620 °	38.722620 °
				-121.806958 °	-121.806958 °
DWR ID	DWR_NA0021_01_f_2015_22				
Comment Code					
RA : Ramp					
Inspector Comment					
There is an unauthorized vehicle ramp by owner on the waterside slope.

Perspective view of the trail on the waterward side of the levee looking downstream. Fall 2015.

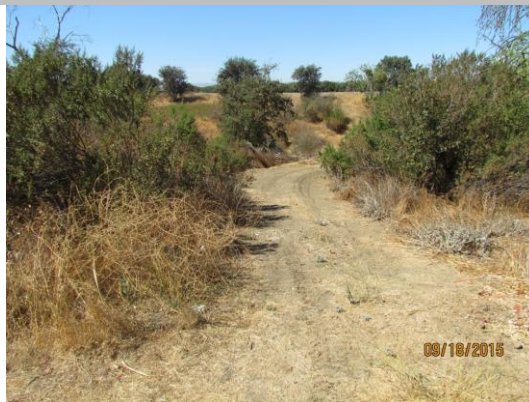
Photo 2 of 3 : SP_2019_NA0021_351_22_20190304_00014.jpg

View of the trail on the waterward side of the levee. Fall 2015.

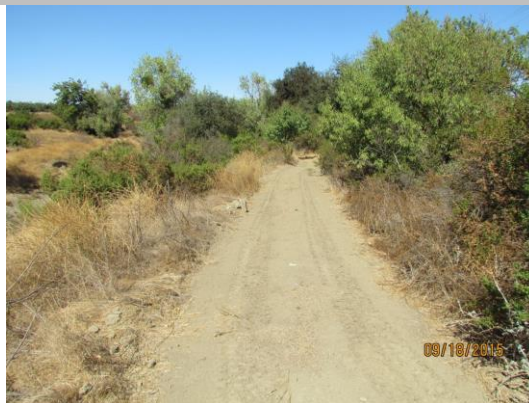
Photo 3 of 3 : SP_2019_NA0021_351_22_20190304_00015.jpg

LM Start	0.27	Rating **	M	Issue No.	22 (cont)	
LM End	0.27	Issue Type +	En	Location *	WS	
Category	Earthen Levee			GPS Latitude/Longitude		
				Start		End
Item	Encroachments			38.722620 °		38.722620 °
				-121.806958 °		-121.806958 °
DWR ID	DWR_NA0021_01_f_2015_22					
Comment Code						
RA : Ramp						
Inspector Comment						
There is an unauthorized vehicle ramp by owner on the waterside slope.

The trail seems to be an access point that leads down to Cache Creek.
Fall 2015.

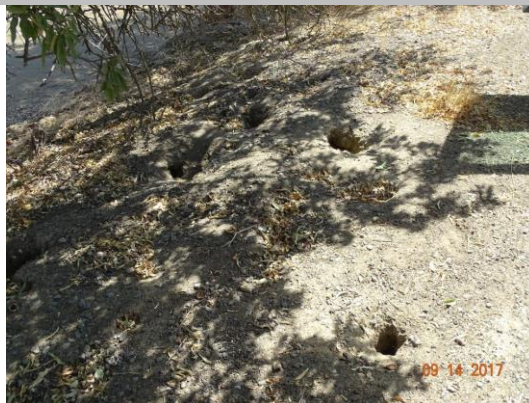
Photo 1 of 1 : SP_2019_NA0021_351_3_20190304_00001.jpg

LM Start	0.45	Rating **	M	Issue No.	3
LM End	0.45	Issue Type +	Ma	Location *	LS
Category	Earthen Levee			GPS Latitude/Longitude	
				Start	End
Item	Animal Control			38.725115 °	38.725115 °
				-121.806527 °	-121.806527 °
DWR ID	DWR_NA0021_01_f_2017_3				
Comment Code					
A3 : No rodents visible, but rodent burrows visible; need to backfill and compact or grout burrows.					
Inspector Comment

Rodent holes on landward hinge point. Fall 2017.
